**Flood Control Project Maintenance
Levee Inspections**

Fall 2010 Levee Maintenance Deficiency Summary Report

Sutter Maintenance Yard East-West Interceptor

Levee Inspection Report By Mile - Fall 2010

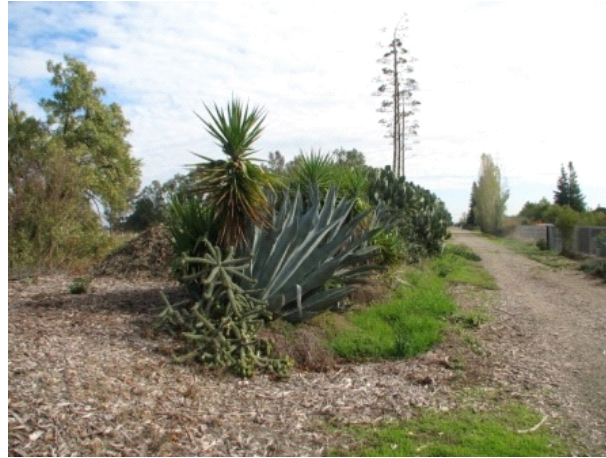
rduffey_f_20101109_255.jpg

Levee Mile Report Line	1
Start Levee Mile	0.23
End Levee Mile	0.25
Location	Crown
Category	Earthen Levee
Item	Encroachments

View of cactus and pine trees along the land side toe.

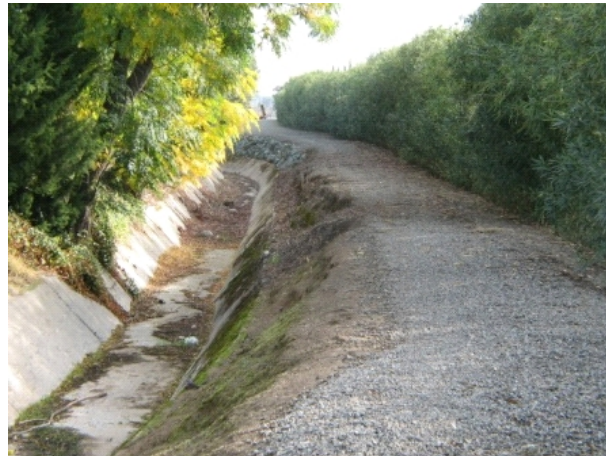
rduffey_f_20101109_256.jpg

Levee Mile Report Line	2
Start Levee Mile	0.62
End Levee Mile	0.65
Location	Water Side
Category	Earthen Levee
Item	Erosion / Bank Caving

View of the erosion along the concrete ditch on the waterside slope.

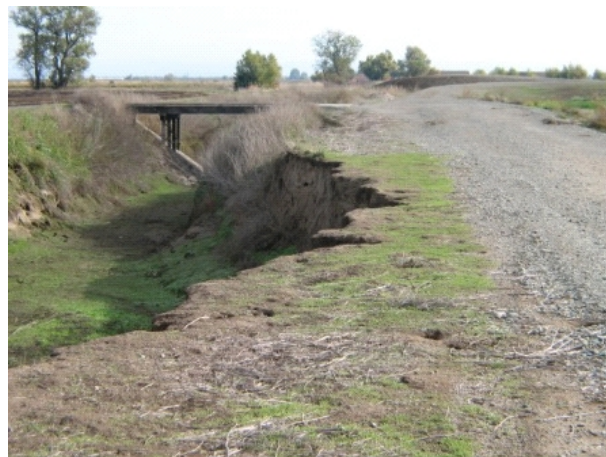
rduffey_f_20101109_257.jpg

Levee Mile Report Line	3
Start Levee Mile	1.67
End Levee Mile	1.67
Location	Water Side
Category	Earthen Levee
Item	Erosion / Bank Caving

View of the erosion along the waterside slope.

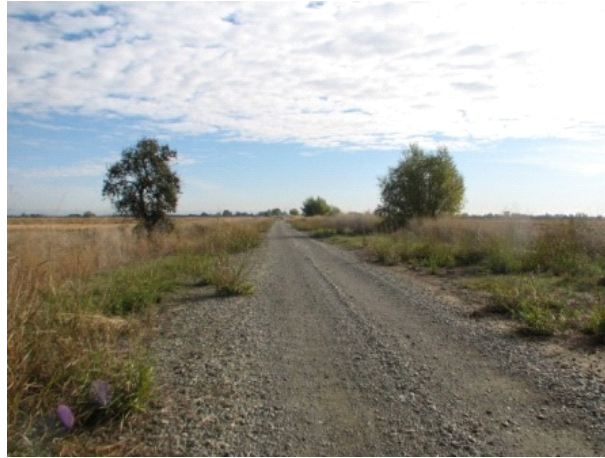
rduffey_f_20101109_261.jpg

Levee Mile Report Line	1
Start Levee Mile	0.55
End Levee Mile	1.55
Location	Land Side
Category	Earthen Levee
Item	Vegetation

View of the grasses and vegetation on both slopes.

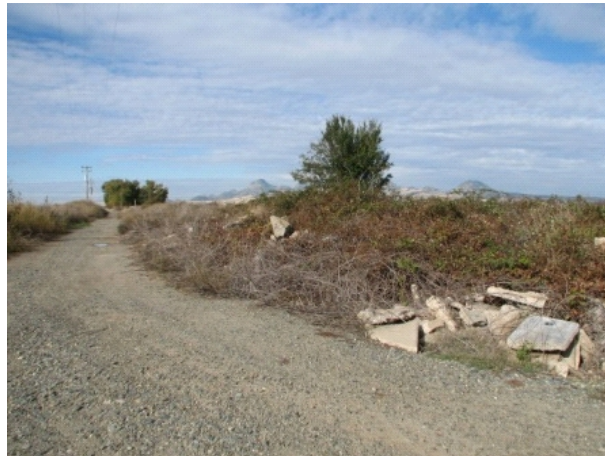
rduffey_f_20101109_260.jpg

Levee Mile Report Line	3
Start Levee Mile	1.43
End Levee Mile	1.55
Location	Land Side
Category	Earthen Levee
Item	Encroachments

View of the pile of broken concrete next to the levee.

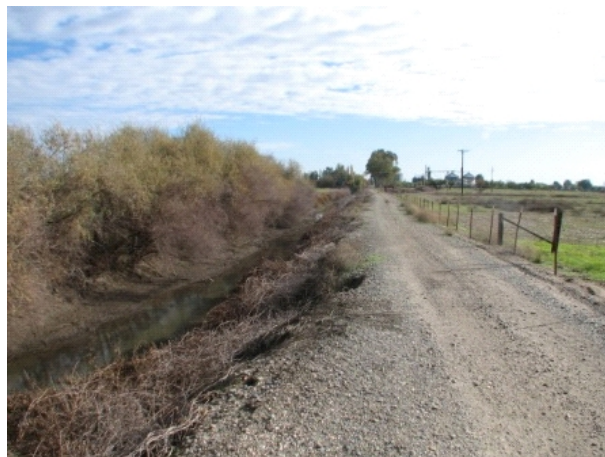
rduffey_f_20101109_259.jpg

Levee Mile Report Line	4
Start Levee Mile	1.54
End Levee Mile	1.93
Location	Water Side
Category	Earthen Levee
Item	Erosion / Bank Caving

View of the erosion along the waterside slope.

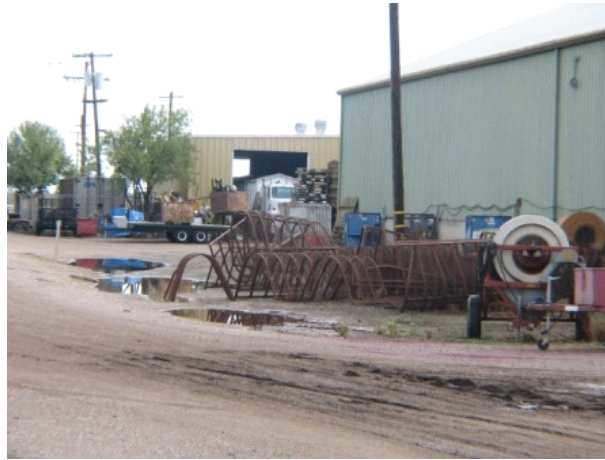
rduffey_f_20101109_258.jpg

Levee Mile Report Line	5
Start Levee Mile	1.92
End Levee Mile	2.04
Location	Land Side
Category	Earthen Levee
Item	Encroachments

View of the equipment and buildings next to the landside berm.
